Final Report: Yaquina and Alsea River Basins Estuarine Wetland Site Prioritization Project *

For:
MidCoast Watersheds Council
157 NW 15th
Newport, OR 97365
(541) 265-9195

By:
Laura Brophy
Green Point Consulting
Corvallis, OR 97330
(541) 752-7671
e-mail: laura@greenpointconsulting.com
website: greenpointconsulting.com

September 1999

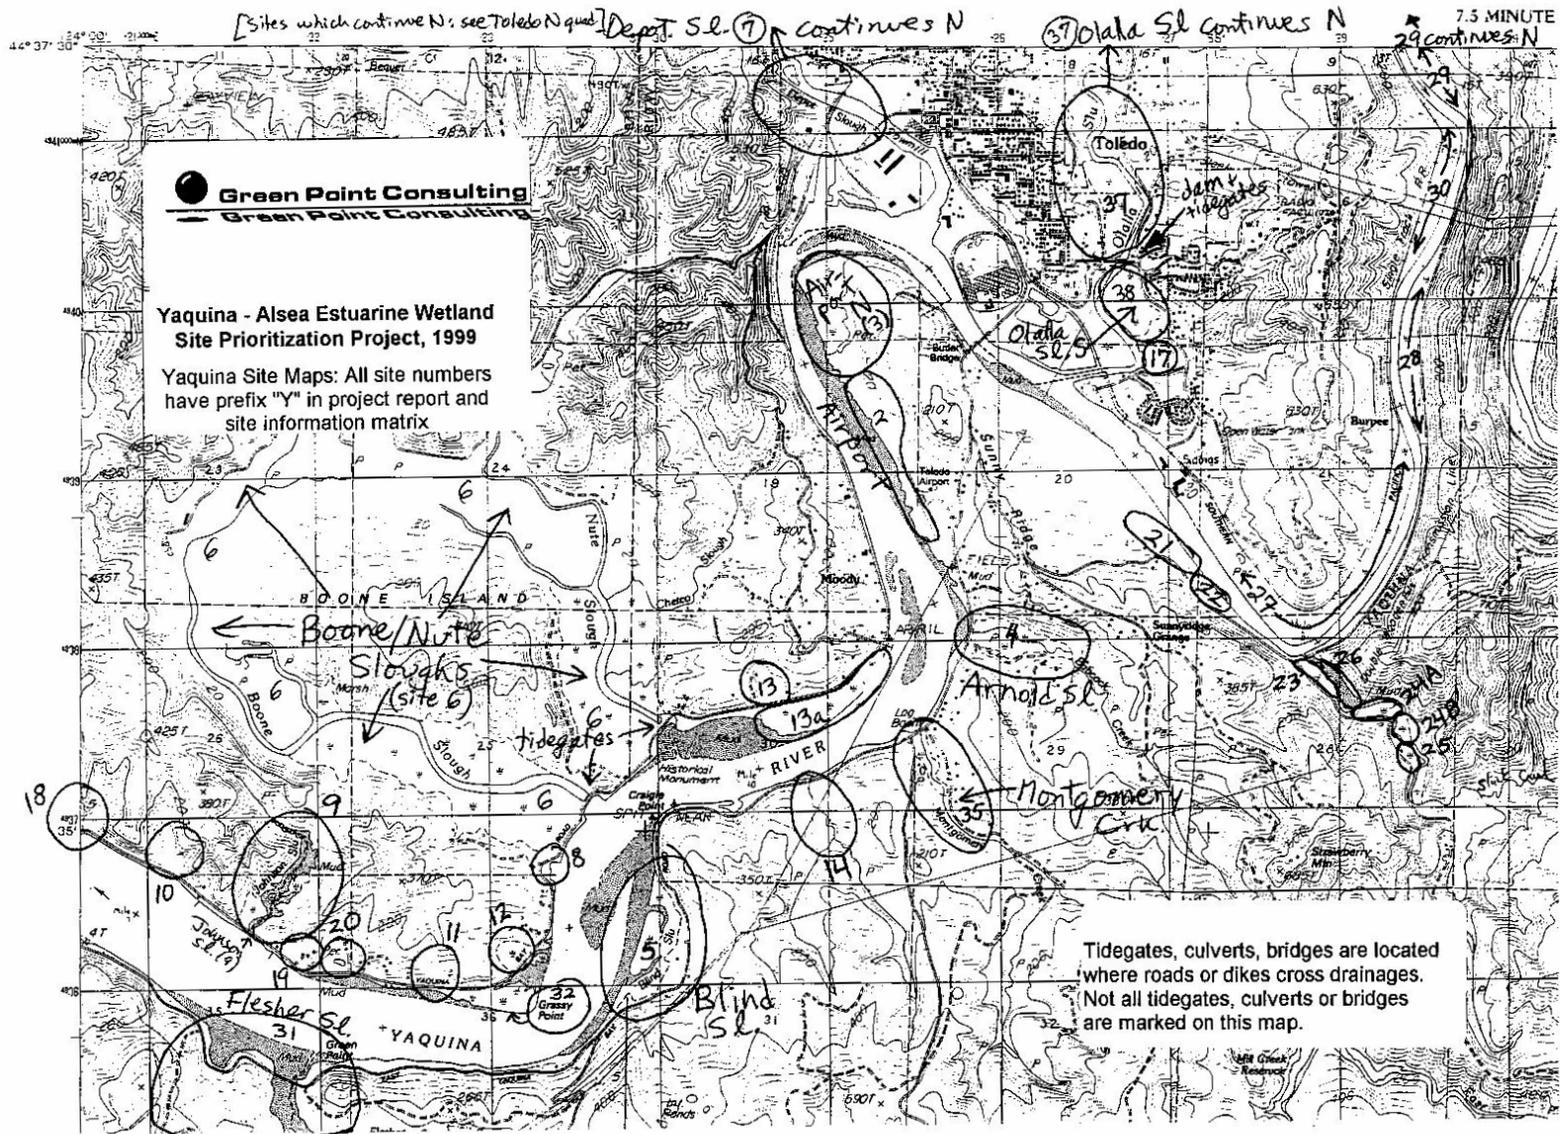
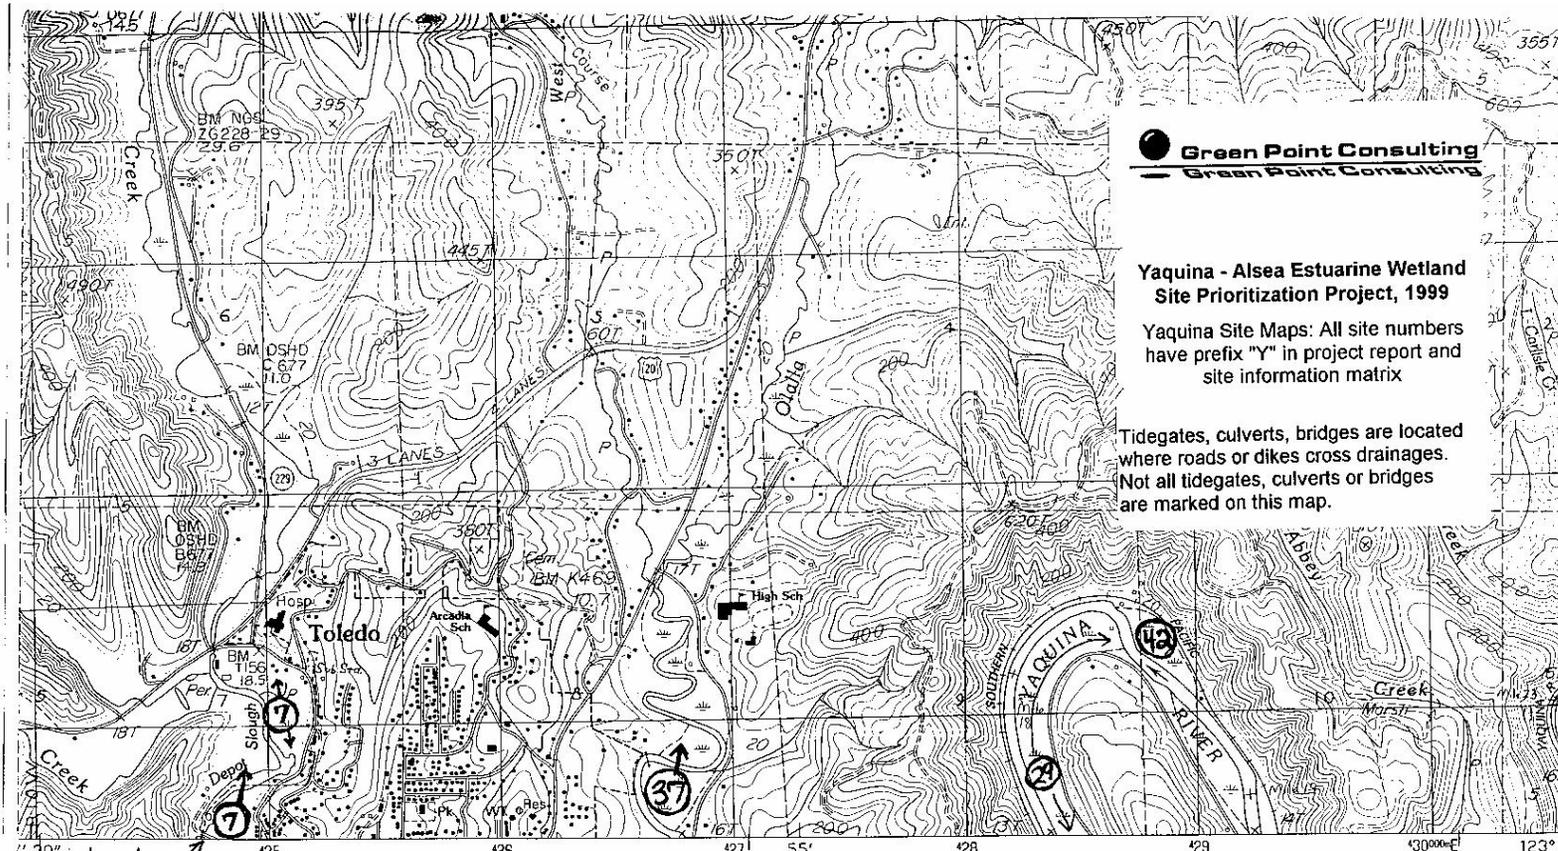
Yaquina Site Maps: All site numbers have prefix "Y" in project report and site information matrix

Tidegates, culverts, bridges are located where roads or dikes cross drainages. Not all tidegates, culverts or bridges are marked on this map.

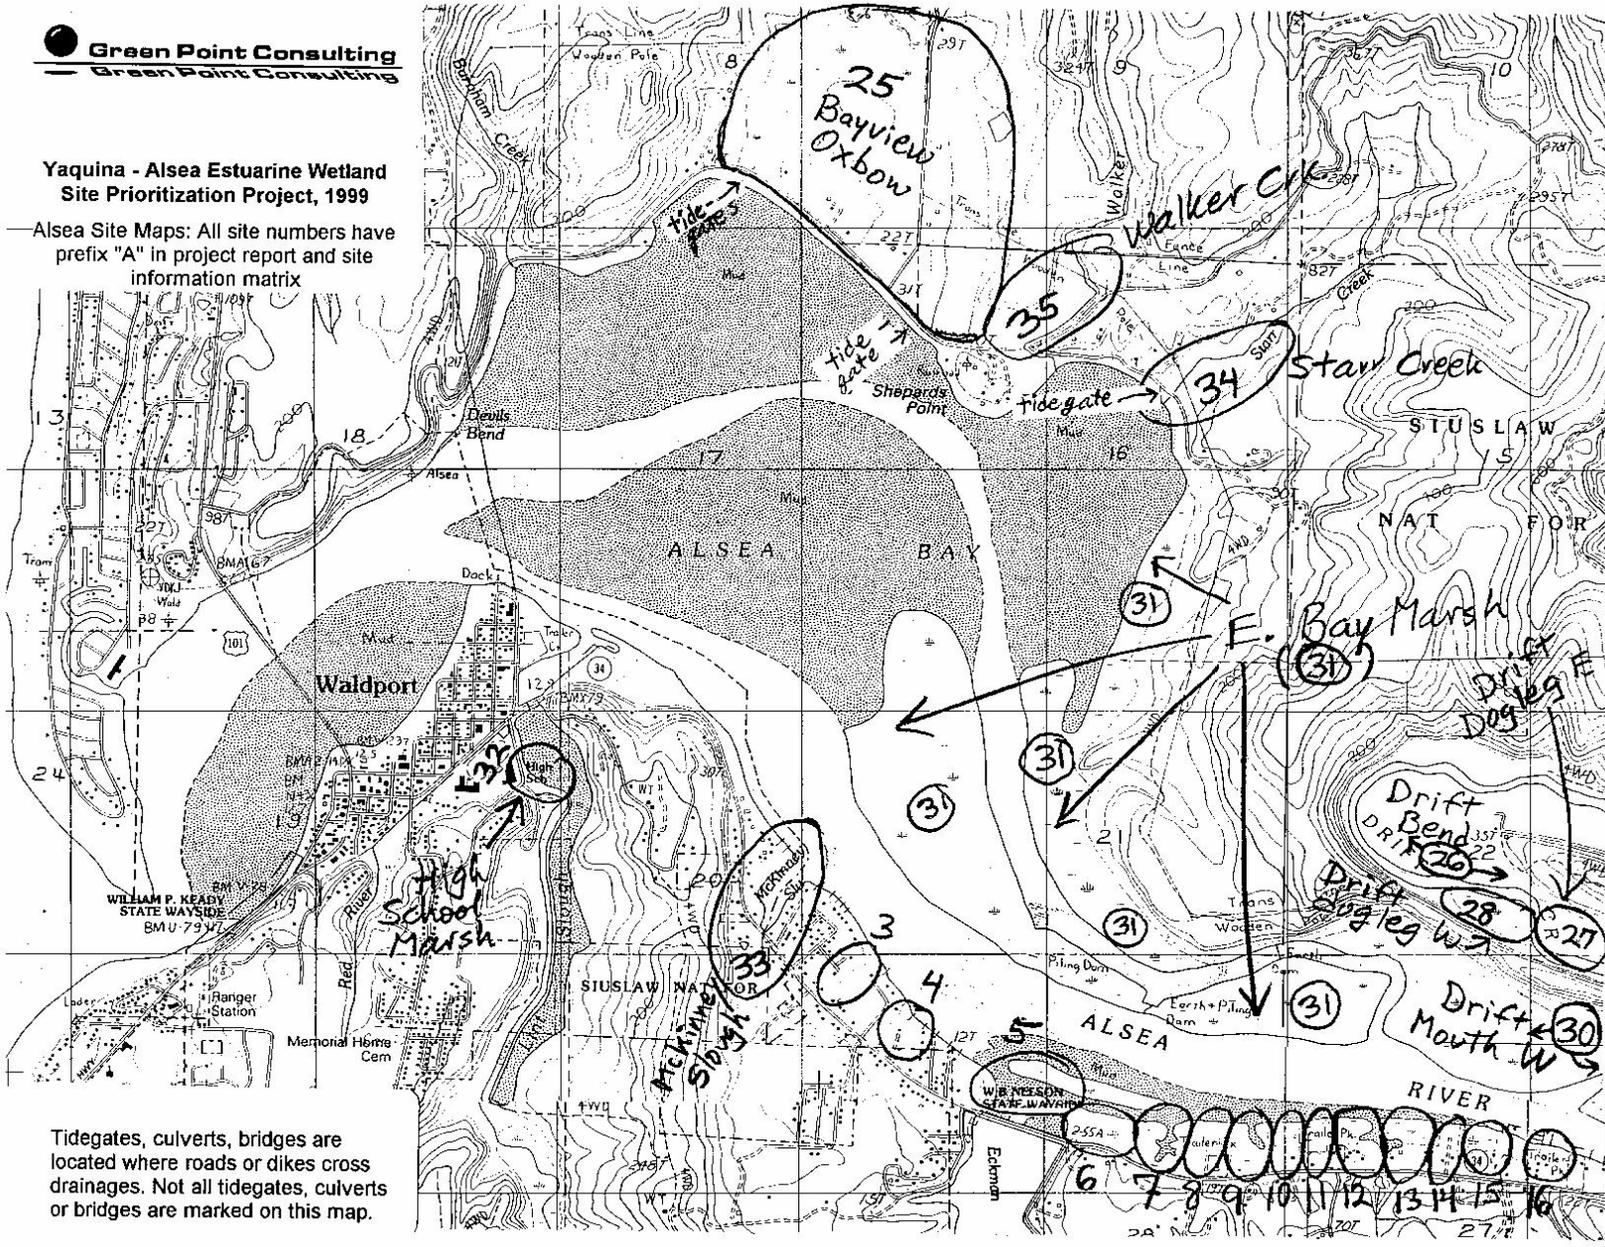
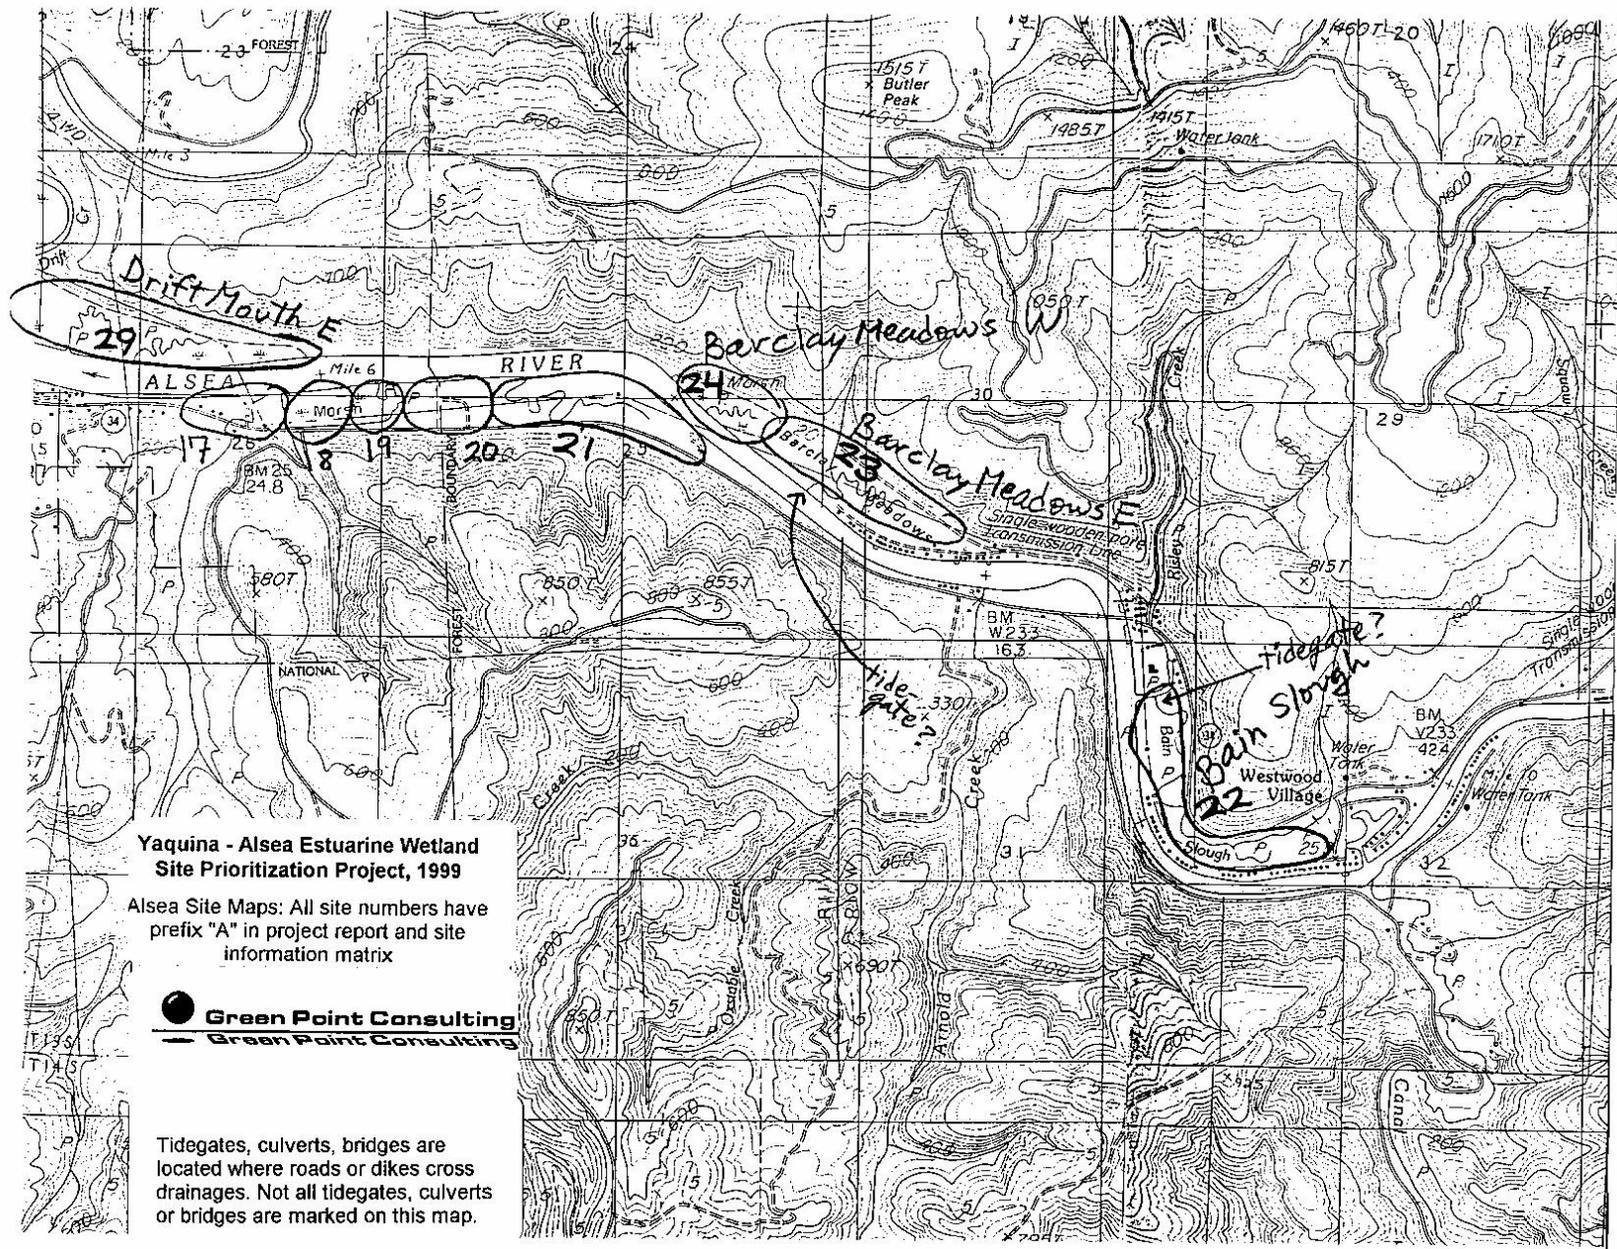
Alsea Site Maps: All site numbers have prefix "A" in project report and site information matrix

Tidegates, culverts, bridges are located where roads or dikes cross drainages. Not all tidegates, culverts or bridges are marked on this map.
